# NIGERIA GURARA

KAPLAN PLANNERS LTD.

## SOIL SURVEY REPORT

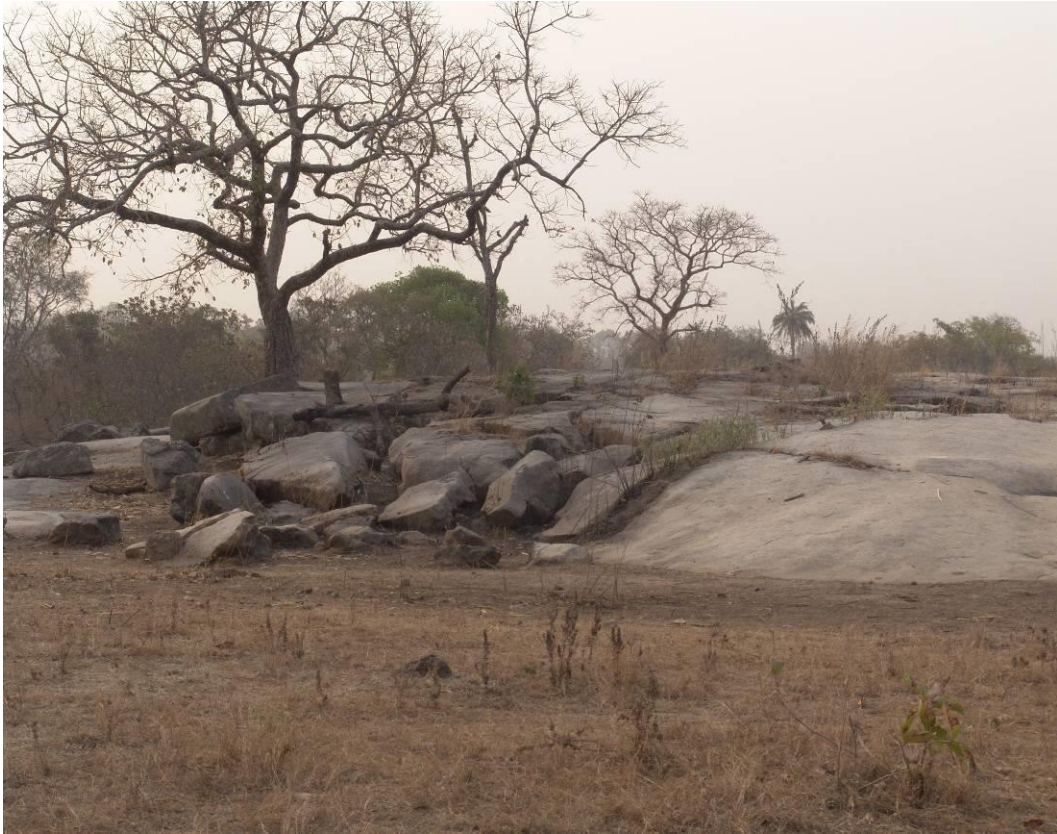
**Picture No. 1**

Rock surfaces are exposed in certain areas, beyond the wide mapped rock surfaces. The rocks appear as rock plates and large chunks. The surrounding soil is deep and is not affected by stoniness.

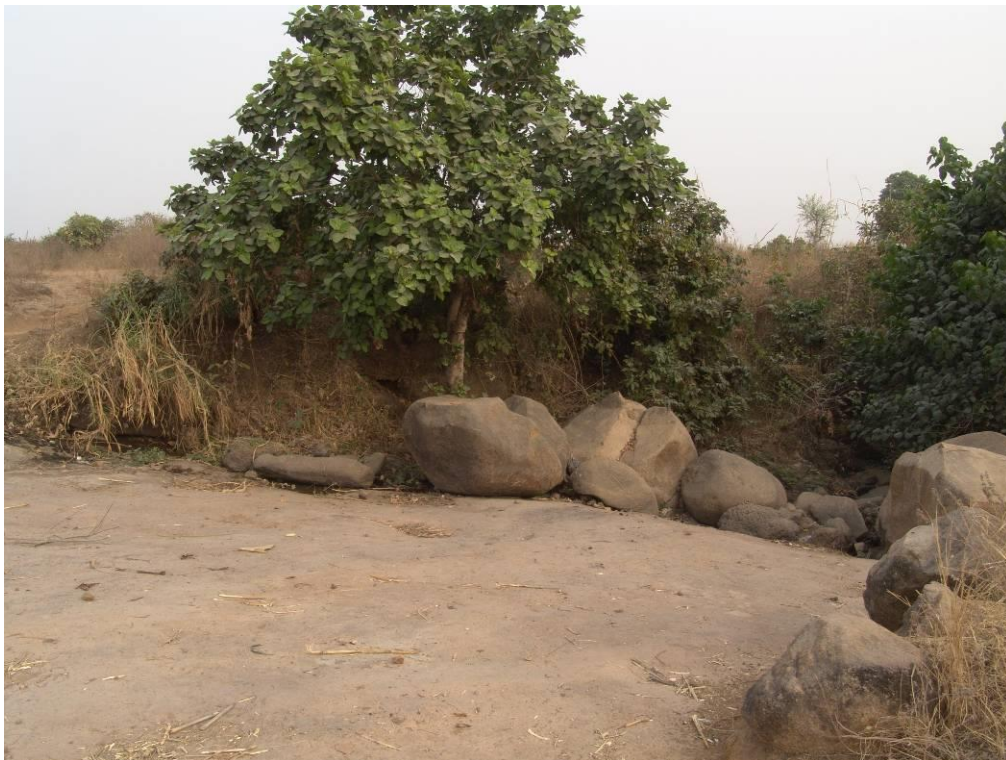
**Picture No. 2**

Rock surfaces and large rocks piled along their edges.

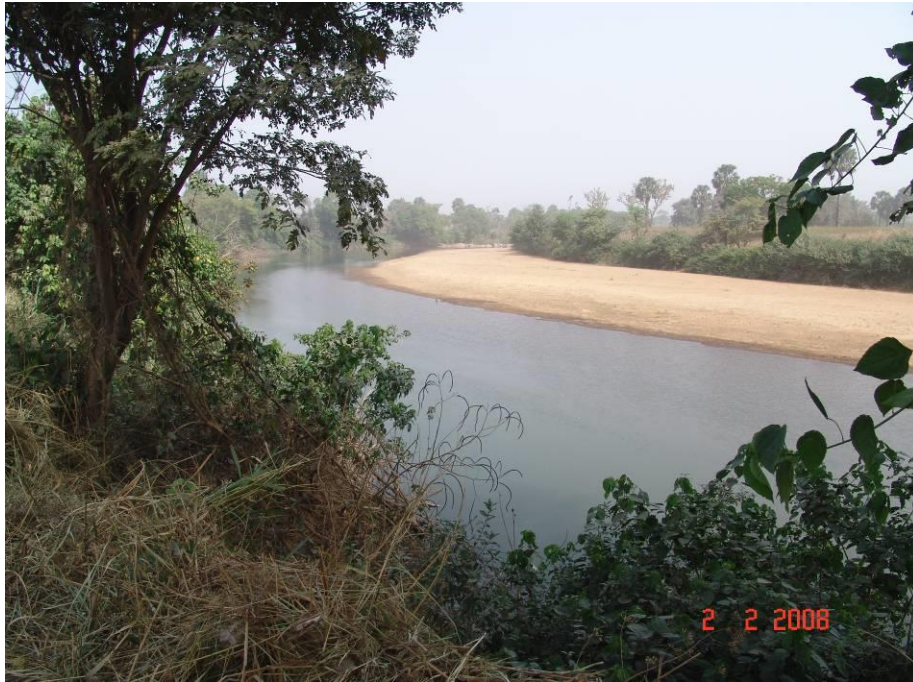
**Picture No. 3**  
The Gurara River. Sandy material accumulation on the northern bank.

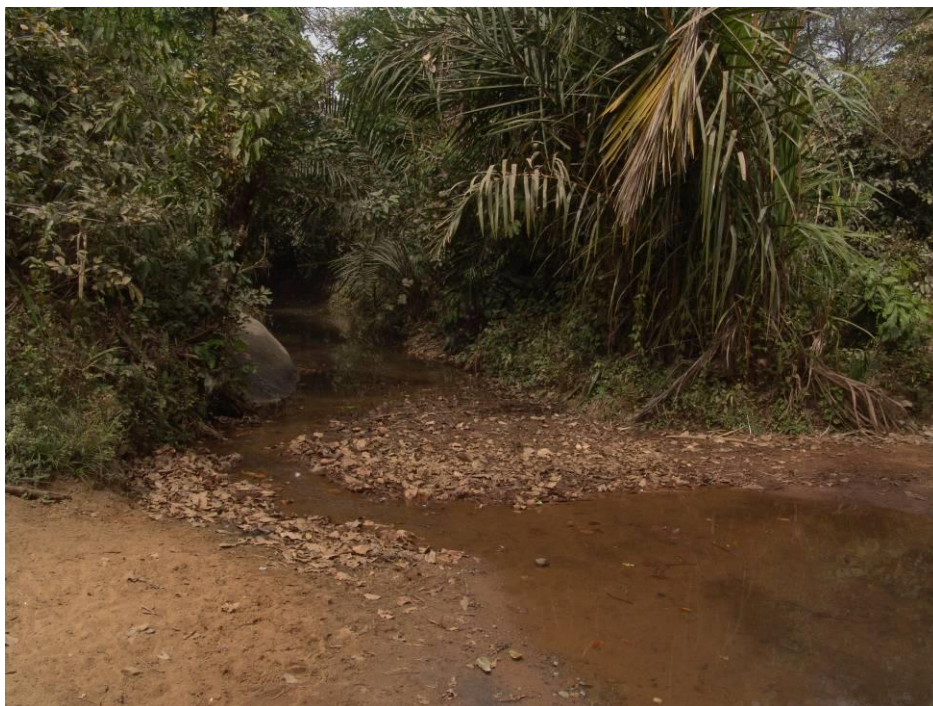
**Picture No. 4**  
A characteristic view of a tributary flowing to the Gurara River. The tributary's surrounding are usually covered with dense vegetation. Some of the tributaries are cultivated, while water flows in others throughout the year.

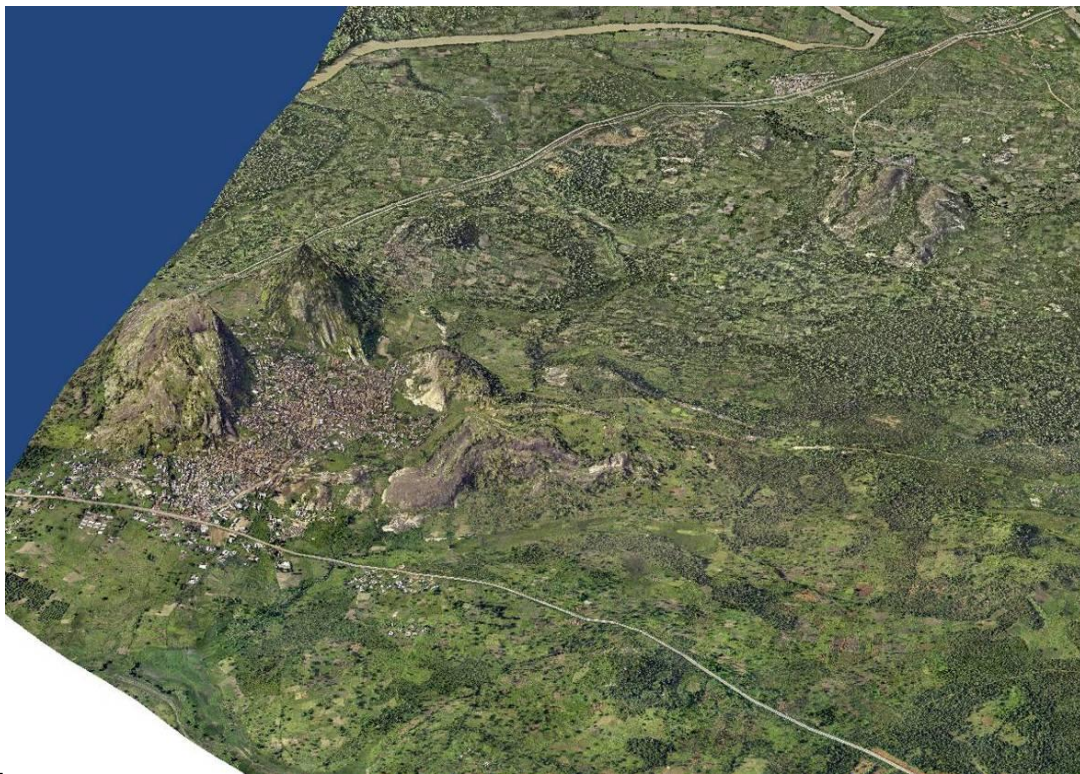
**Map No. 6** settlement distribution

The project's area covers approximately – 8000 hectares. Jere, a large village of 2,000 dwellings, lies in the south–eastern part of the area. The village's houses stretch along the main road to the north, and along the road to the east. Except for this village, there are also small village concentrations consisting of a few scattered houses. Map No. 6 shows the population's distribution in the project's area. The area occupied by dwellings covers about 140 hectares, approximately 1.7% of the area.

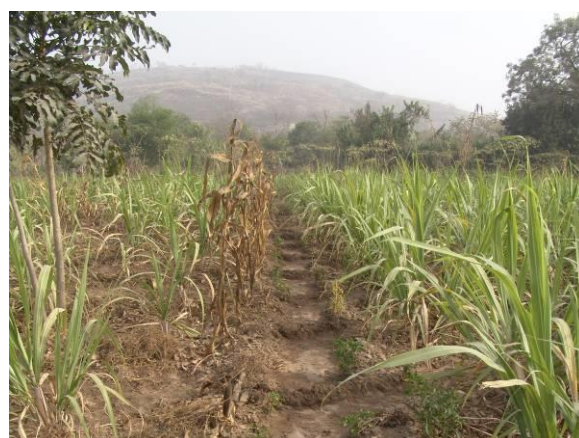
**Picture No. 13**  
Furrow irrigation near the Gurara River

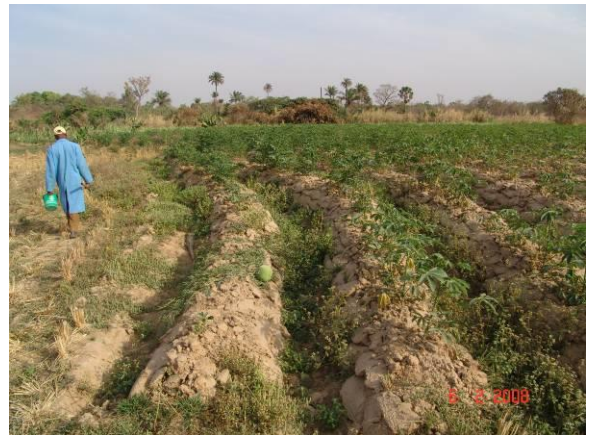
**Picture No.14**

A watermelon and cassava field near the banks of the Gurara River raised furrows, irrigated by flooding.

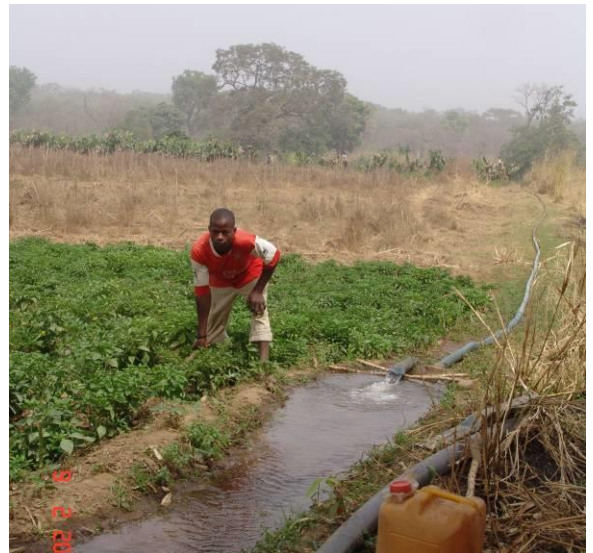
**Picture No. 15**

Pumping water from the Gurara River with a hose, and drawing them to the fields for irrigation purposes.

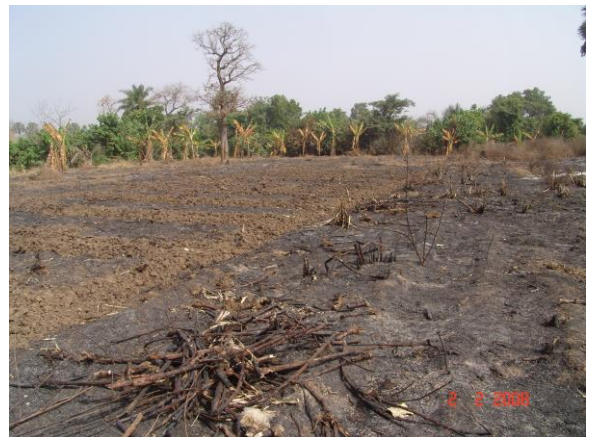
**Picture No.18**

Cultivation plots are burnt, as part of a routine farming method of pruning and burning, in order to prepare the soil for cultivation. At the far end of the area banana trees can be seen.

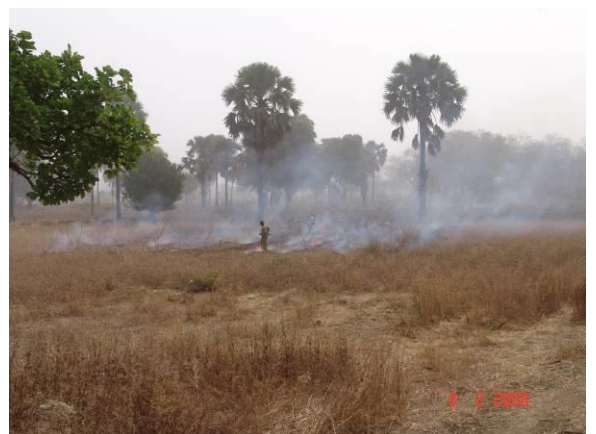
**Picture No. 19**

Supervised burning as part of the area's preparation for cultivation.

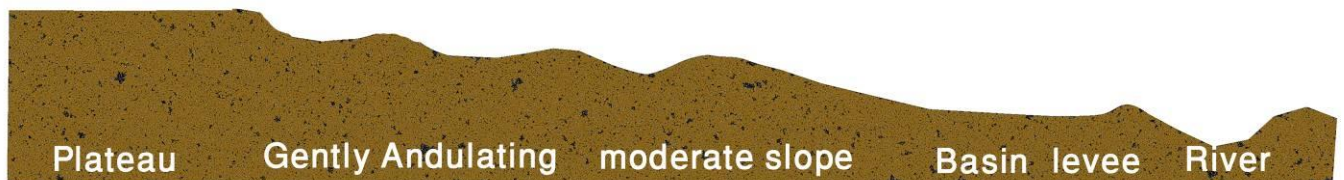
Illustration No. 1 Cross Section

The following cross section (see illustration No. 1) of the project area depicts the gently undulating topography and the distribution of the soil units accordingly.

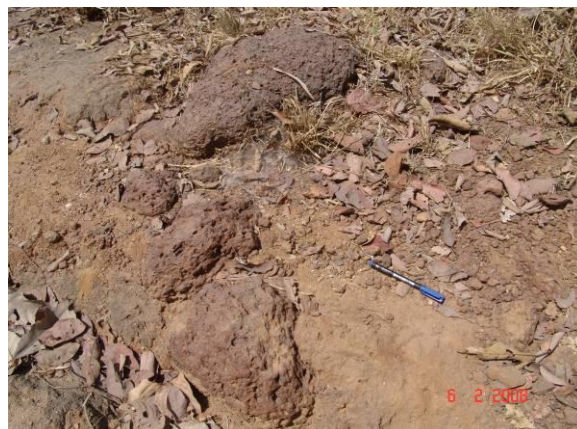
**Picture No. 25**

Lumps of hard metallic laterite, appear as hard stones tightly pressed to the surface, creating an impermeable cover. This situation is common in steep areas where the laterite is exposed. A close view of the rock allows us to discern between the rock's different shades, as a result of different oxidation and reduction situations.

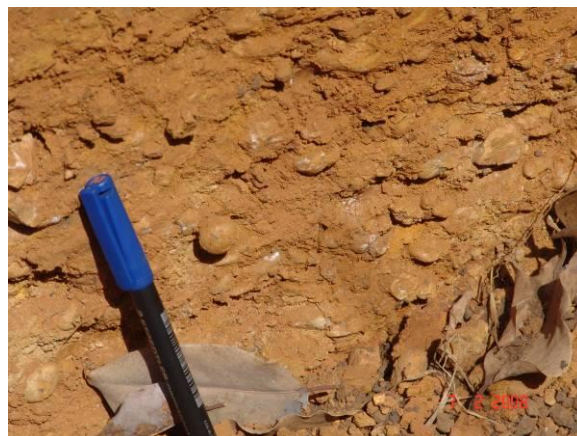
**Picture No. 26**

Rounded iron concretions in a characteristic horizon of lateritic soil.

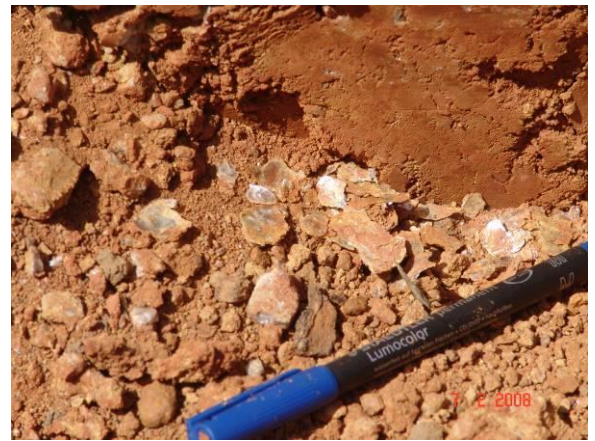
**Picture No. 27**  
Rounded iron concretions in a characteristic horizon of lateritic

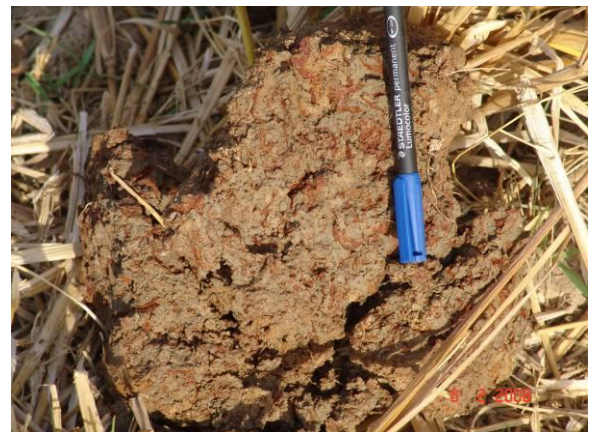
**Picture No. 28**  
Iron manganese concretions, in a soil chunk going through a lateritization process

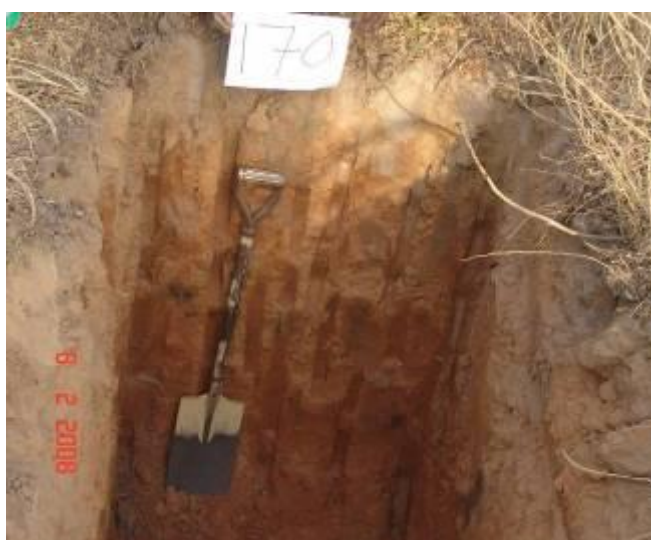
**Picture No. 29**  
Exposed profile of Yellow – brown soil in a typical digging point

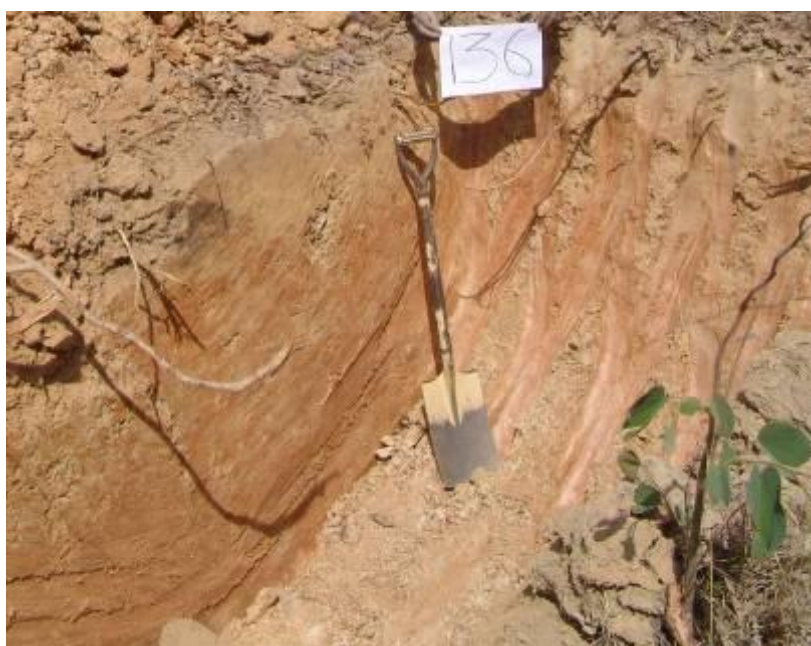
**Picture No. 30**

Exposed profile of Red Laterite soil in a typical digging point

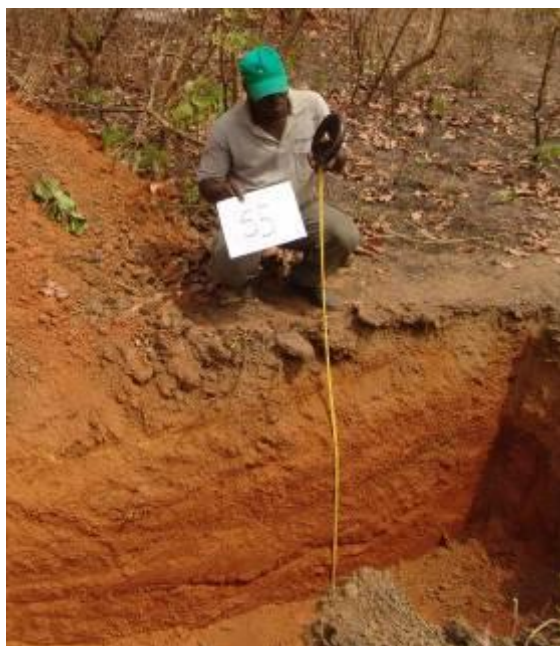
**Picture No.31**  
Exposed profile of Weathered Laterite soil in a typical digging point

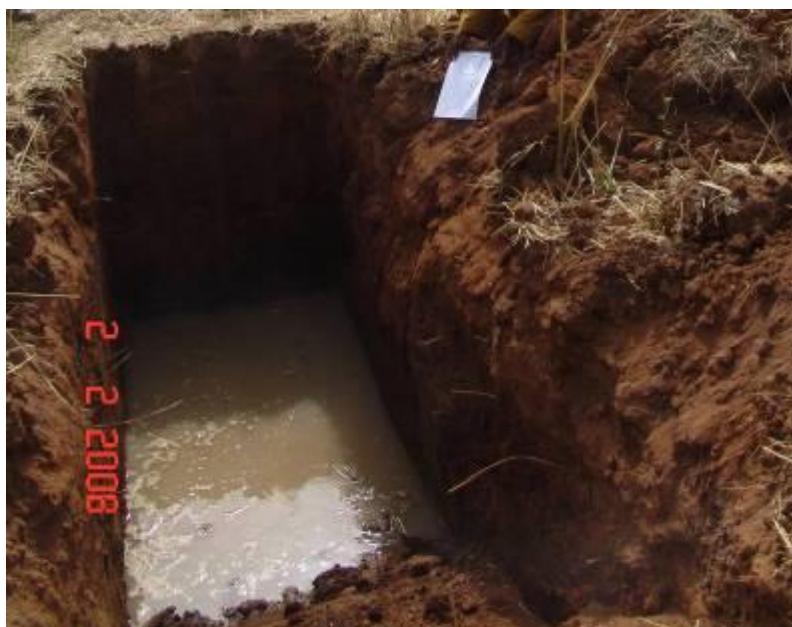
**Picture No. 32**

An exposed profile of alluvium Gurara River soil in a typical digging point (ground water appear close to soil surface)

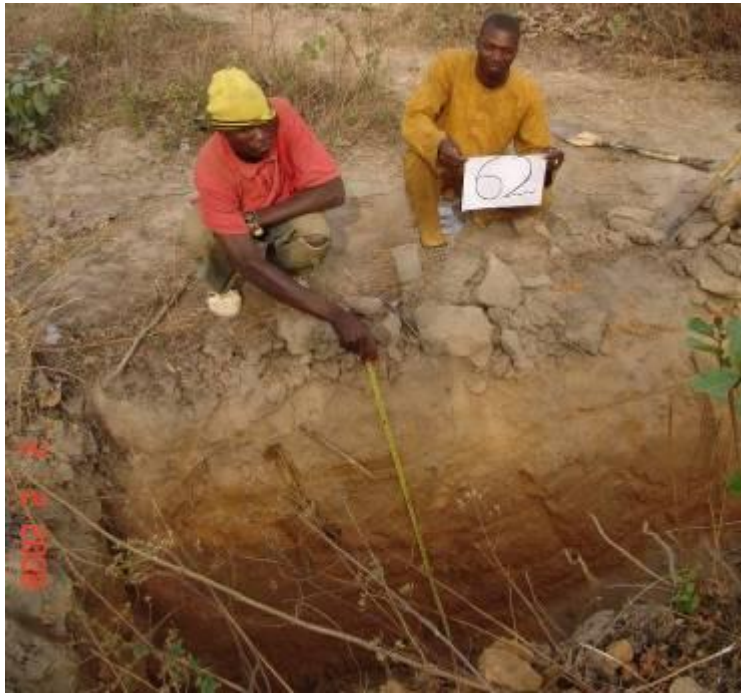
**Picture No. 33**  
Exposed profile of alluvium secondary river soil in a typical digging point
